Using IR Thermal Imaging to Engage Students in Campus Energy Awareness

Building: Grise Hall

CASE STUDY: GRISE HALL

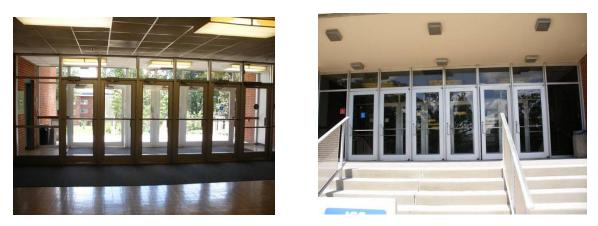
Thermograms of several door and window panels were taken by a student energy auditor from the department of engineering. Figure 1 shows interior and exterior photographs of the vestibule type door and window panel of the main floor lobby, which are the primary entry doors for the building. This six door and ten single pane window panel faces southward. Visual inspection indicated that the window glazing and caulking was in obvious need of repair due to oxidation and UV exposure. Similarly, door seals and sweeps were either damaged or missing, resulting in loss of an air seal around their perimeter.

Figure 1 Photographs of the GH Main Lobby Vestibule Type Door and Window Panel - Interior and Exterior

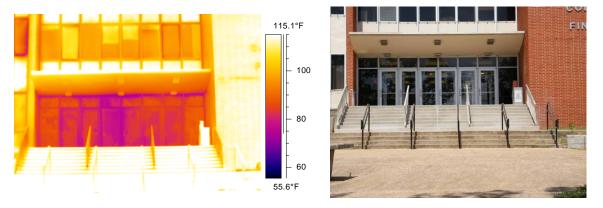
An overview thermogram and photograph pair for this door and window panel is shown in figure 2. The impact of the air imbalance and the compromised door and window seals is apparent in the infrared thermogram, which shows the patterns of conditioned air leaking around the compromised seals and from the center exterior door, which consistently failed to close completely due to the excessive interior building pressure.

Figure 2 Thermogram and Photograph Pair of GH Main Lobby Vestibule Type Door and Window Panel

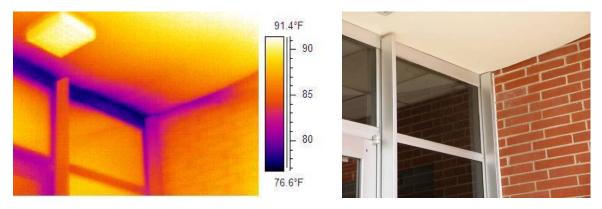
The compromised window seal is shown in the close-up images and photographs of the upper right corner of the entryway overhang in figures 3 and 4. A patterning of light and dark striations is particularly apparent in the higher contrast gray palette image in figure 4. This "visualized" air leakage pattern shows the convective cooling of the exterior surfaces by the conditioned air from the interior building space, resulting in possibly significant energy loss from the building space possibly compromising human comfort in the occupied space.

Figure 3 Thermogram and Photograph Pair of Main Lobby Overhang

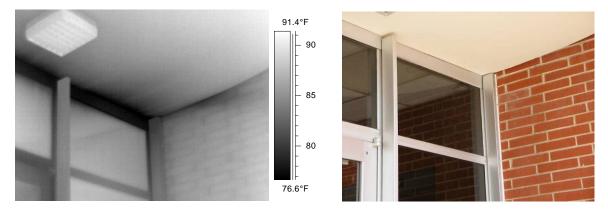
Figure 4 Thermogram and Photograph Pair of Main Lobby Overhang

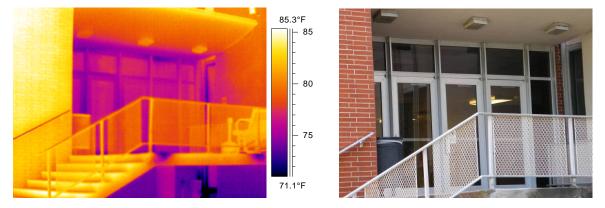
The single bank doors on the westward facing 2nd floor lobby were also evaluated for air leakage. This panel consists of four doors and eight single pane windows. The overall physical condition of this panel was similar to the main entryway door panel with obvious seal performance degradation due to age and weather exposure. As stated previously, doors in this panel would also not completely close due to the air imbalance. The entire door and window panel had been reset in the structure when it was dislodged due to the air pressure imbalance.

Figure 5 shows a thermogram and photograph pair of the door and window panel with apparent air leakage pattern similar to the vestibule type door on the 1st floor lobby. Figure 6 provides detailed images of the upper and lower sections of the panel. As with the vestibule type door panel, cooler conditioned air leakage around the compromise door and window seals is convectively cooling the adjacent overhang and wall exterior surfaces as shown in figures 5 and 6 thermograms.

Figure 5 Thermogram and Photograph Pair of GH 2nd Floor Lobby Single Bank Door and Window Panel

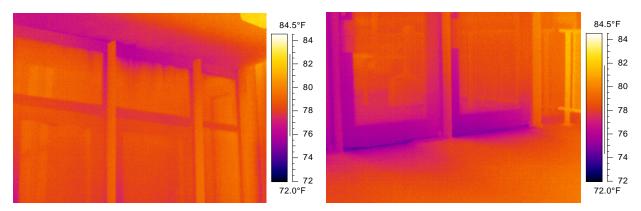
Figure 6 Thermograms of Upper and Lower Sections of GH 2nd Floor Lobby Single Bank Door and Window Panel

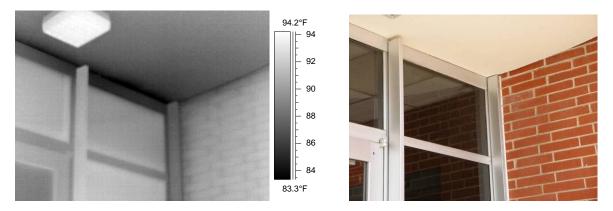
Figure 7 Thermogram and Photograph Pair of Main Lobby Overhang After Return AHU Modifications

A minimal "visualized" air leakage pattern is evident of the overhang in this new thermogram, which indicates a significant reduction in the convective cooling of the exterior surfaces by the conditioned air from the interior building space. The differential pressure measurements under these operating conditions were also repeated by the student energy auditors and are provided in Table 2.

When the return air handlers were reactivated and reinstalled where necessary to save energy, the building was revisited by student energy auditors, and thermograms and differential pressure measurements were repeated. The compromised window seal shown in figure 4 is shown on the revisit in figure 7.
