A Field Investigation of a Large Collapsed Structure: A Student Engagement Project

Abstract – A large barn structure located in a rural county in Kentucky collapsed during construction on October 14th, 2006. As the crane was moving the last truss into position, the entire roof system suddenly collapsed. The cause of the collapse was not immediately known. Within days of the collapse, students in a junior level structural analysis course got an opportunity to investigate first hand to determine the cause and the sequence of events that lead up to and during the collapse. Based on documented site visits and on statements given by the contractors and the owner, who were present at the time of the collapse, students were required to investigate and write a report to determine the cause and nature of the collapse. The focus of this paper is to present the results and work performed by the students.

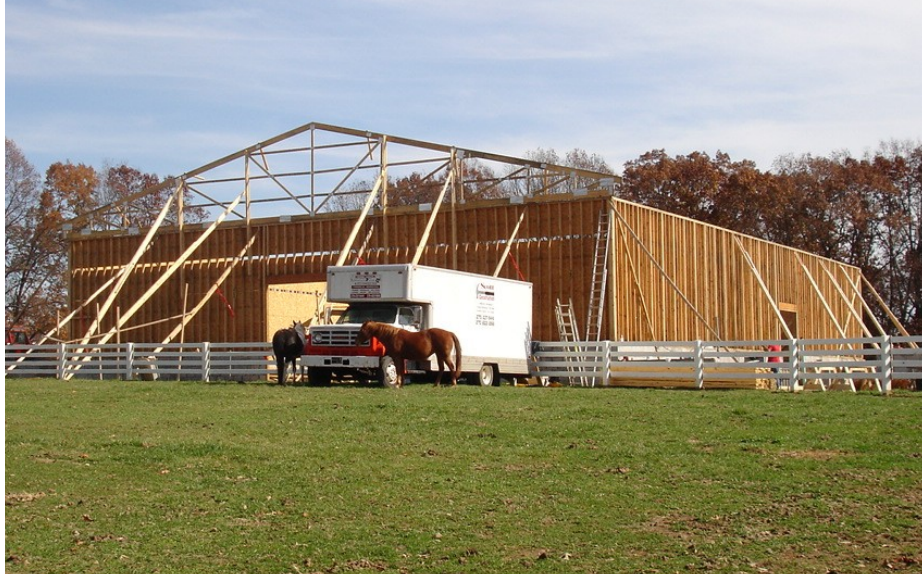
A large private barn structure located in a small rural county in Kentucky collapsed during construction on October 14th, 2006. See Figures 1 and 2. The horse barn was 80 ft wide by 120 ft long in plan and had 80 ft long wooden roof trusses. As the crane moved the last truss into position on the end wall of the barn, the entire roof truss system suddenly collapsed. The surrounding walls remained in place. However, one of the exterior walls bowed outward requiring immediate bracing of the wall to prevent additional outward movement of the wall.

Figure 1: The exterior of the collapsed barn looking north

Knowing the recommendations of the Guide [5], the students went back and read the statements given by the contractor at the time of the collapse. The exterior walls were all properly braced. The south exterior gable truss (GE-1) was externally diagonally braced at four (4) locations. See Figure 1. Only, the first and third quarter points at top chord were braced. The other two braced locations were near the middle of the truss but were braced at the midheight of the truss’ web. On the barn’s interior, this truss was also braced at top chord at the first and third quarter points of the truss. The interior diagonal bracing at the first and third quarter points also attached to the second and third trusses (T-1 and T-2) at the web and bottom chord, respectively. The remaining trusses (T-3 through T-23) were only braced horizontally along top chords at six (6) locations and along bottom chord at four (4) locations. No other diagonal bracing was provided to the top chords or to the webs of the trusses.

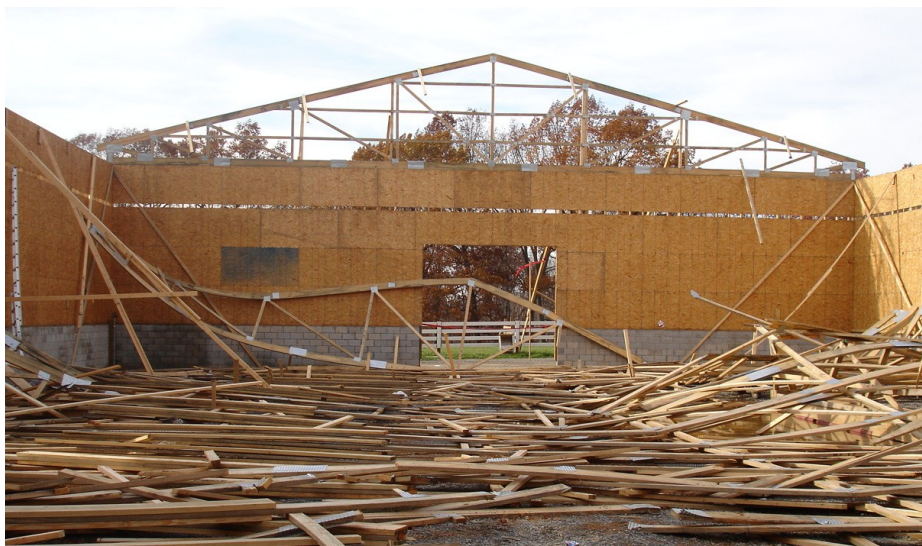
Figure 2: The collapsed trusses looking south

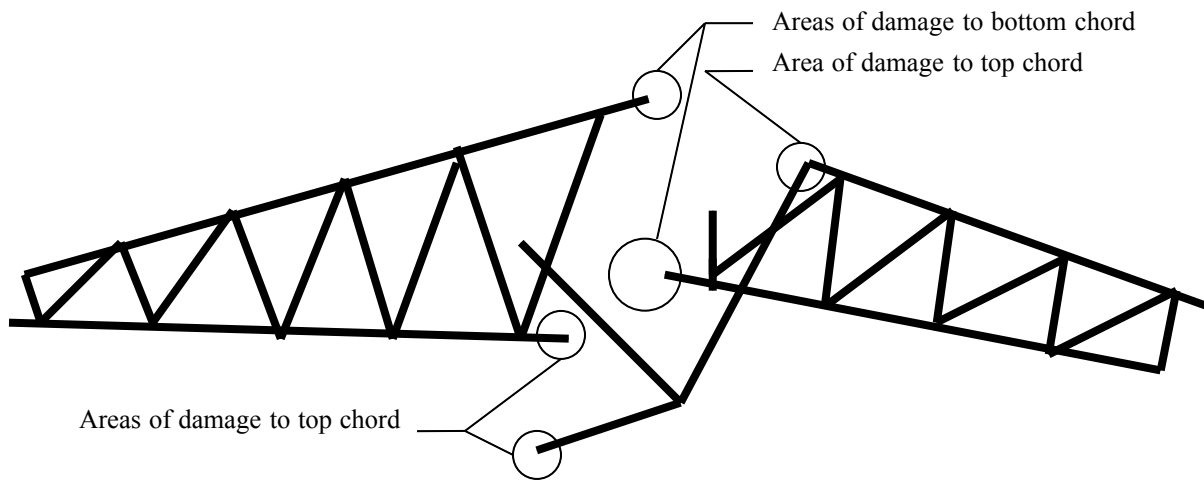
The top chord of the third truss (T-2) appears to have buckled and twisted out of the plane of the truss, causing the east half of the truss to twist and fall back to the south onto the east half of the second truss (T-1). See Figures 5 through 7. The impact knocked the second truss (T-1) off its east bearing. The east end of this truss then fell to the ground, causing significant damage near midspan along bottom chord, where the moment is maximized. The remaining west half of the third truss (T-2) twisted and fell to the north toward the fourth truss (T-3). See Figure 8. At which point, the remaining trusses (T-4 through T-23) began to topple on top of each other and collapse in a domino like manner, one on top of the other.

Figure 5: Truss 3 (T01-2) collapsed looking from above

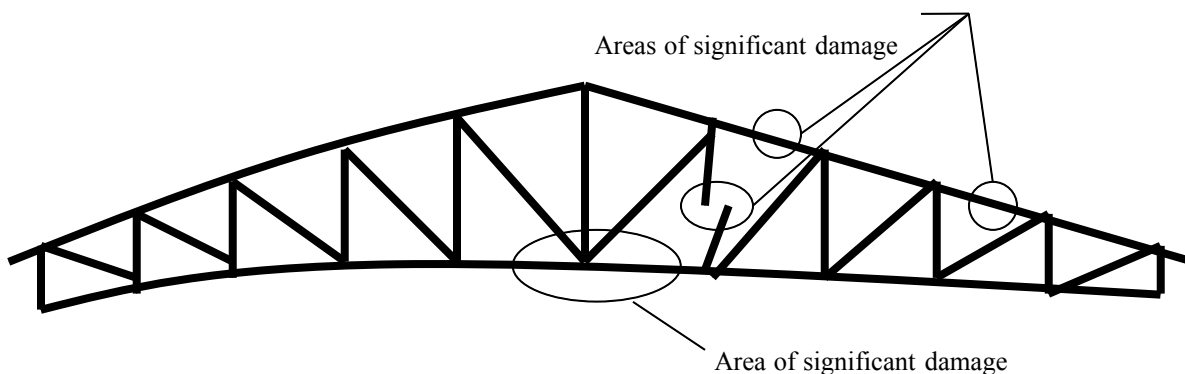
Figure 6: Truss 2 (T01-1) collapsed looking from above

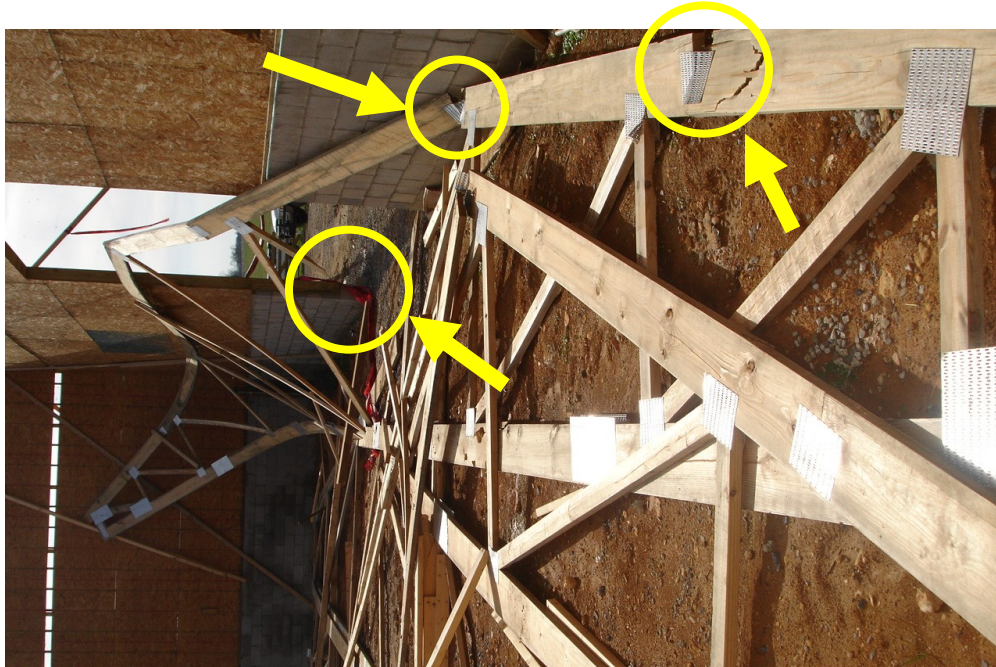
The design of the trusses for the structure, based on the specifications provided by the truss manufacturer, was satisfactory. The sizes of the plates on the trusses were correct based on the specifications. However, approximately half of the trusses delivered to the site had a broken connection plate, which required repair. Upon further inspection of the collapsed trusses, gaps (not due to the collapse) of up to approximately 1/16" between the plates and the wood members were found at some locations. In addition, some plates did not appear to grip well to the wood members, while most did.

Figure 7. Truss 2 (T01-1): areas of significant damage

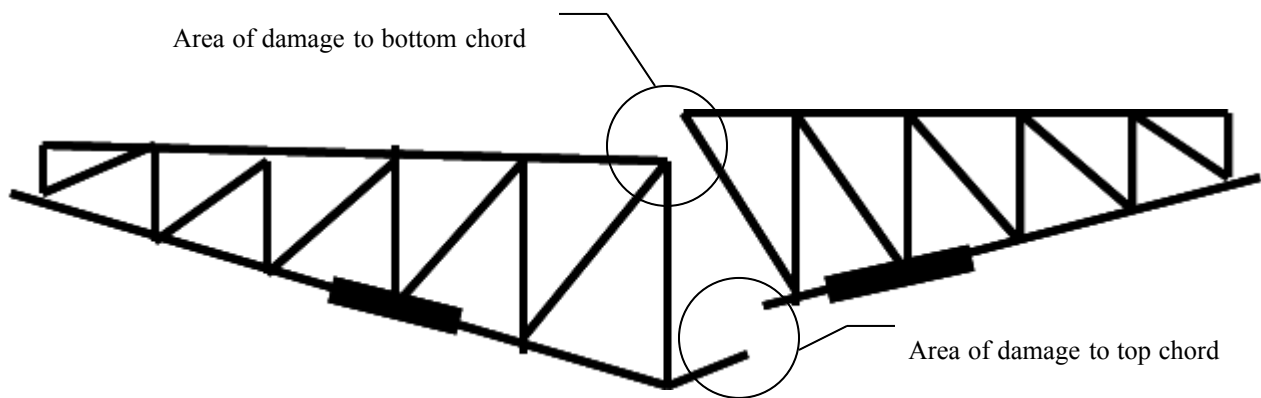
Figure 8: Truss 4 (T01-3) collapsed looking from above

However, the bracing was not adequate to prevent the connected trusses from tipping over as a unit, which is what happened when the west half of the third truss (T-2) fell toward the remaining trusses (T-3 through T-23). This would have been prevented by proper diagonal bracing of the trusses. With the exception of the first two trusses (GE01-1 and T01-1), no other trusses were diagonally braced in the web or at top chord. To prevent a tipping failure of the trusses, diagonal bracing of the trusses was required.

In general, trusses are not marked in any way to identify the frequency or location of temporary bracing, including diagonal bracing. As a result, it is necessary to follow the recommendations as specified in the Building Component Safety Information Booklet (BCSI) (2006) "Guide to Good Practice for Handling, Installing & Bracing of Metal Plate Connected Wood Trusses," Section B10, "Post Frame Truss Installation and Bracing." The guide gives detailed information on how to properly diagonally brace trusses during installation. Proper bracing of the trusses is required.
